Stream Assessment Summary Form (Form 2)

Unified Stream Methodology for use in Virginia

Project #	Applicant	Date
2017-890	Green Ridge Recycling and Disposal Facility	4/11/2022
Evaluators	HUC	Locality
David Kwasniewski, PWD, Kristen Walls, WPIT, Emily Beacham, PE, Eric Myers, Hannah Bullens	02080205	Cumberland Co.

Name(s) of Evaluator(s)	Stream Name and Information
David Kwasniewski, PWD and Eric Myers	Stream Reach 1 - Impact Plate C1.1/Impact 1.1

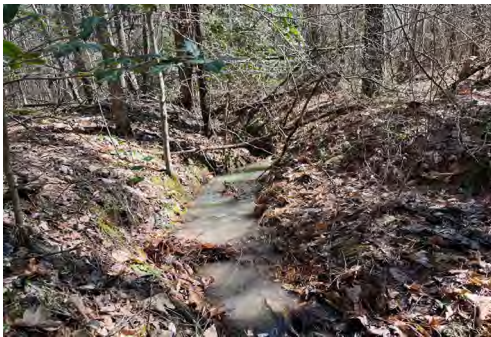
looking upstream

NOTES>> Channel does not have access to its floodplain. Erosion observed along outer meander and toe of slope. Herbaceous vegetation observed stabilizing bank as well as mature trees along banks.
